## **Elevated section of the West Gate Freeway, South Melbourne, Australia. Part 1: design and construction of foundations**

The construction of West Gate Bridge during the 1960s and 1970s reinforced the need for an elevated freeway across the South Melbourne and Port Melbourne areas to remove heavy freight vehicles and through traffic from the overloaded network of commercial and residential streets. Difficult soil conditions and a recent history of bridge collapses (Kings Bridge and the West Gate Bridge itself) meant that the design and construction of the new elevated structures would come under unprecedented scrutiny from all sections of the community. Quality Assurance had to begin at the time of conceptual design, and to be implemented all the way through the design and construction process into the service life of the structures. The introduction of a construction technology—short line match casting of segments—which was new to Australia at the time, also emphasized the necessity for the highest possible level of technical control throughout the project.

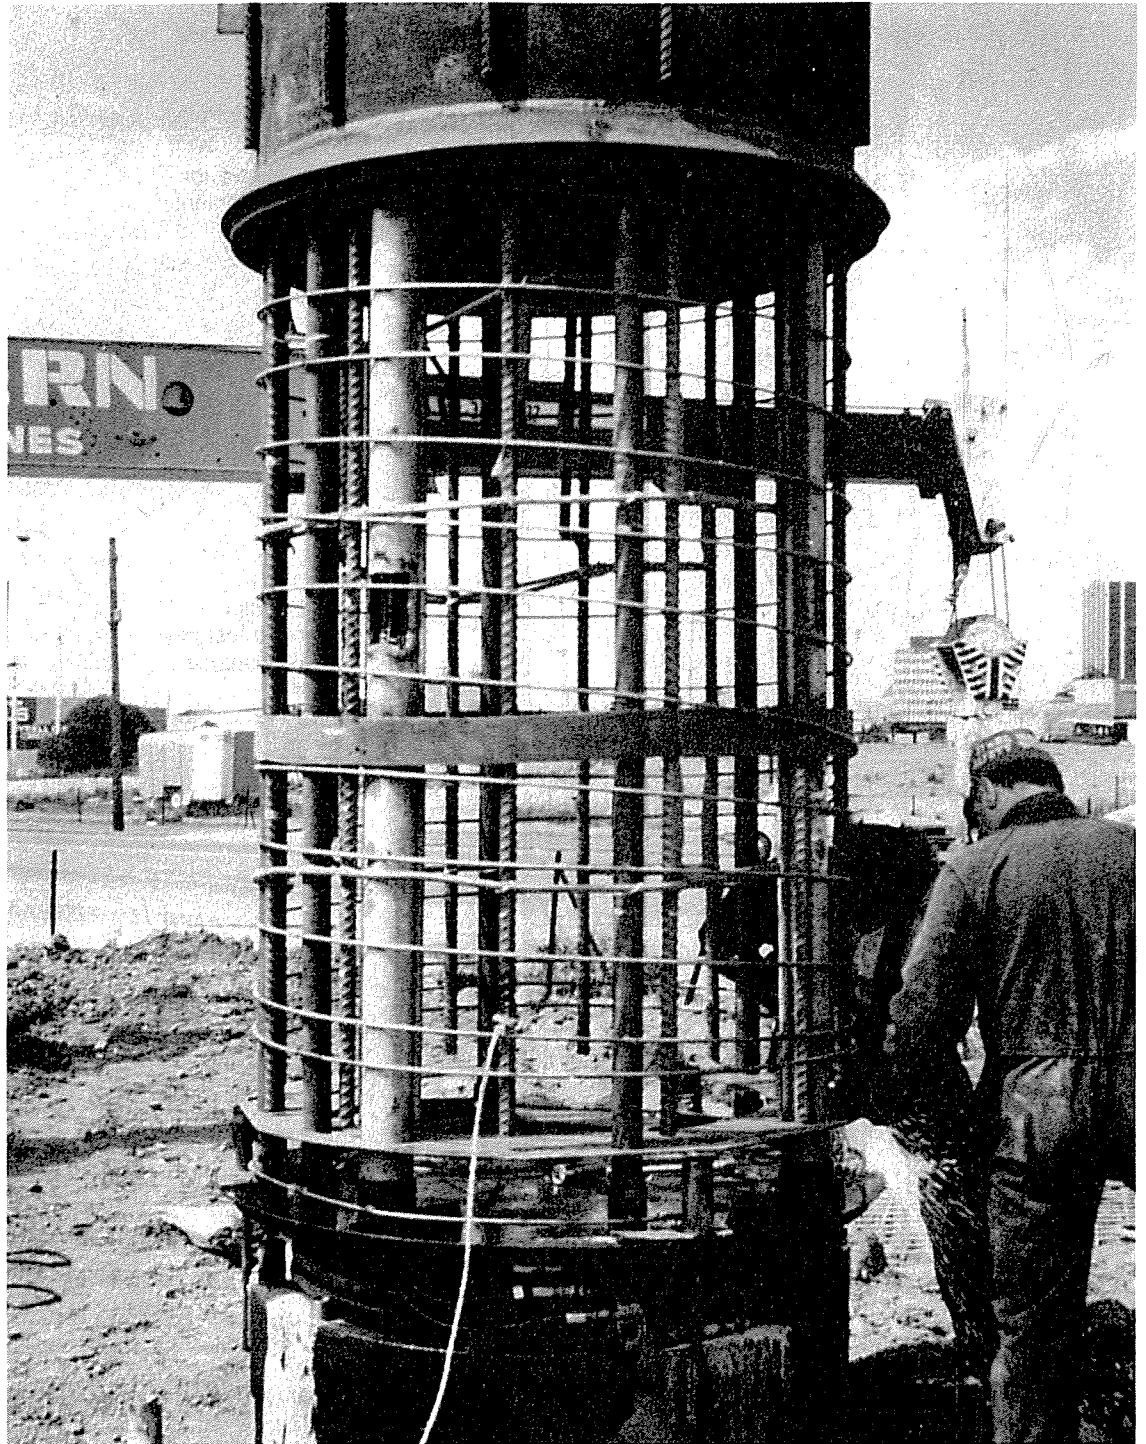
*Fig. 7. Strain gauged reinforcement cage and flat jack assembly being lowered into basalt socket*

24. Rock anchored reaction beams were used to provide the test reaction for three of the basalt pile tests. For the other three tests, a series of four 1.15 m dia. flat jacks were used to provide the reaction. One of the flat jacks was sealed and instrumented with a pressure transducer to record load, while the other three cells were used to increase load. Fig. 7 shows a strain gauged reinforcement cage and flat jack cell assembly being lowered down one of the basalt test pile sockets. Following the test, all flat jacks were grouted to replace the oil so that pile socket

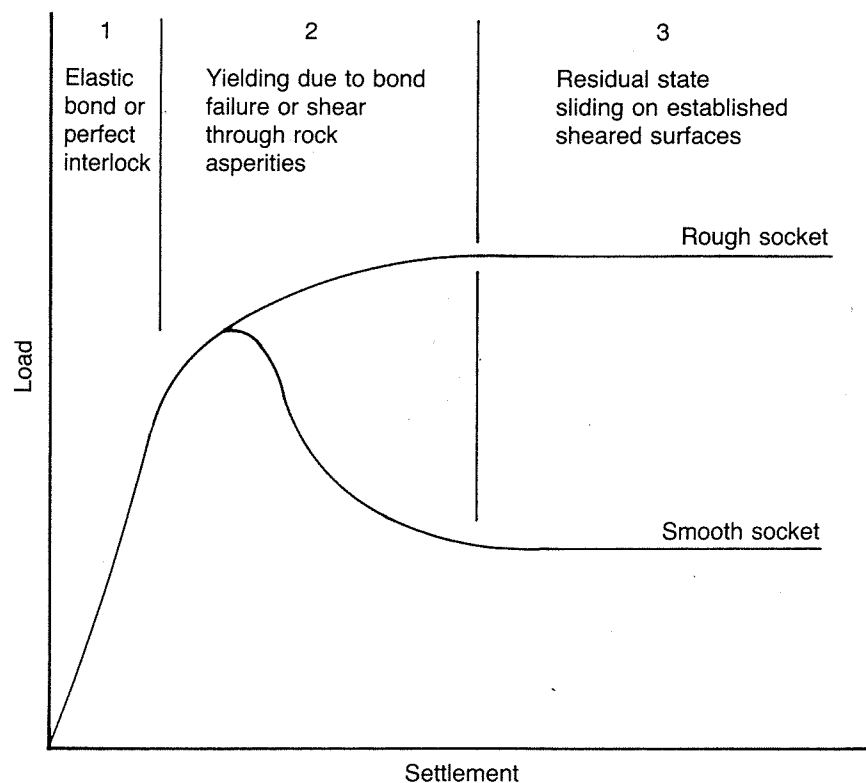
Fig. 9. Load–settlement characteristics for socketed piles—side resistance only

32. If base resistance is neglected, as a pile socket is loaded, the load–settlement behaviour may be assumed to be initially elastic, with no slip or yielding at the socket wall. At higher load levels, some yielding of the rock occurs. With very smooth walled sockets, an abrupt loss of capacity can be experienced once yielding has started. These mechanisms are shown in Fig. 9. In rough sockets, dilatation of the socket occurs under load, resulting in an increase in normal stress and shear resistance capacity until there is shearing through the rough socket asperities.

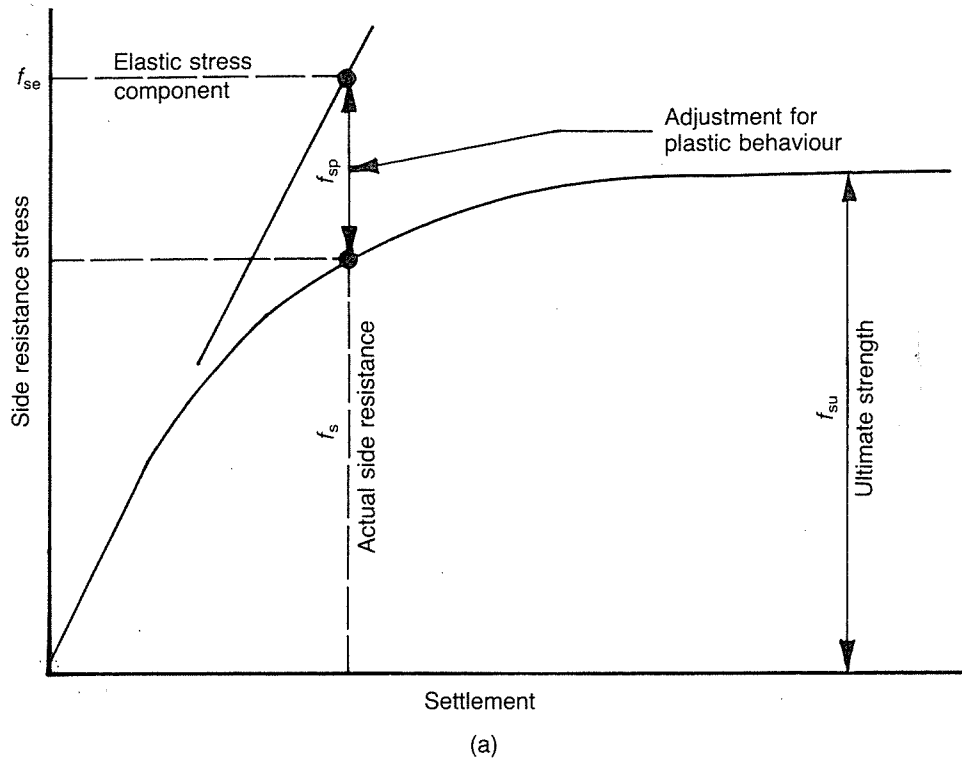
Fig. 11. Definition of terms used to normalize socketed pile design curves allowing for plasticity effects: (a) side resistance curve; (b) base resistance curve

39. At this point, side and base resistance components of capacity were reduced to take into account non-linear load-settlement behaviour shown to be present at relatively low stress levels and attributable to plasticity effects (see Fig. 11). Load-settlement curves from field pile load tests were used to prepare normalized side shear resistance and base resistance curves for design purposes. The ultimate side resistance value ( $f_{su}$ ) and the 1% of diameter base settlement stress ( $f_{b1}$ ) were the parameters selected to non-dimensionalize the side and base resistances. It was found, after normalizing the field test curves, that pile behaviour for a wide range of rock strengths and pile embedment ratios lay within a narrow band of upper and lower bound curves, from which average design curves were constructed (see Fig. 12).

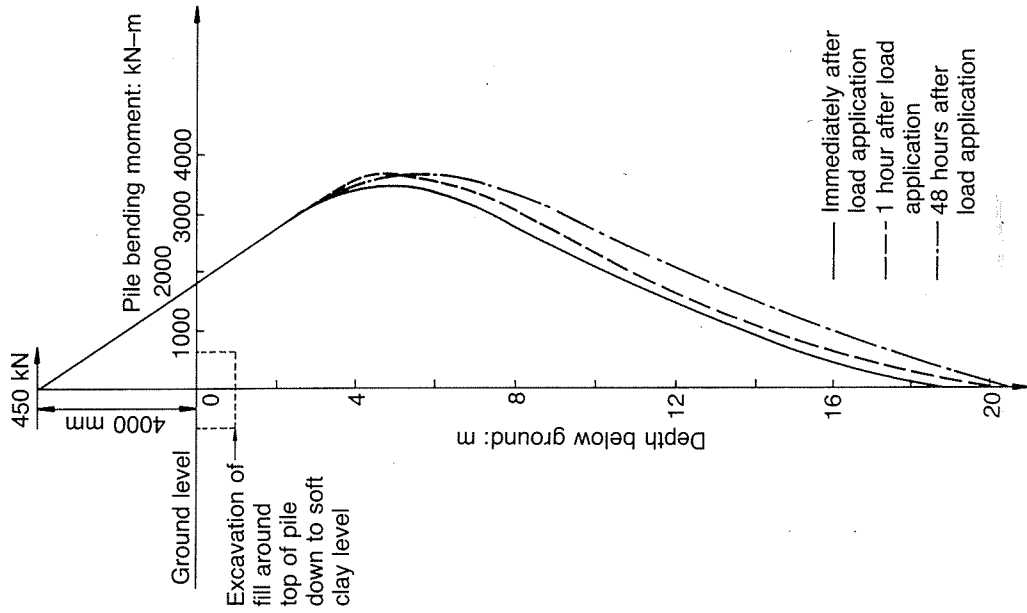
Fig. 13. Laterally loaded pile test results for load applied 4 m above ground level: (a) load-deflection curve; (b) bending moment distribution

47. Strain gauge instrumentation down two of the test piles allowed bending moment distributions to be evaluated. Fig. 13(b) shows bending moment curves

for one of the test piles. The tendency towards increasing bending moment at any particular level with time was attributed to creep and relaxation of the most heavily stressed soil zones near the ground surface. Analysis of the strain gauge information resulted in a change in reinforcement cage proportioning over the upper part of the piles. Socket regions were unreinforced.

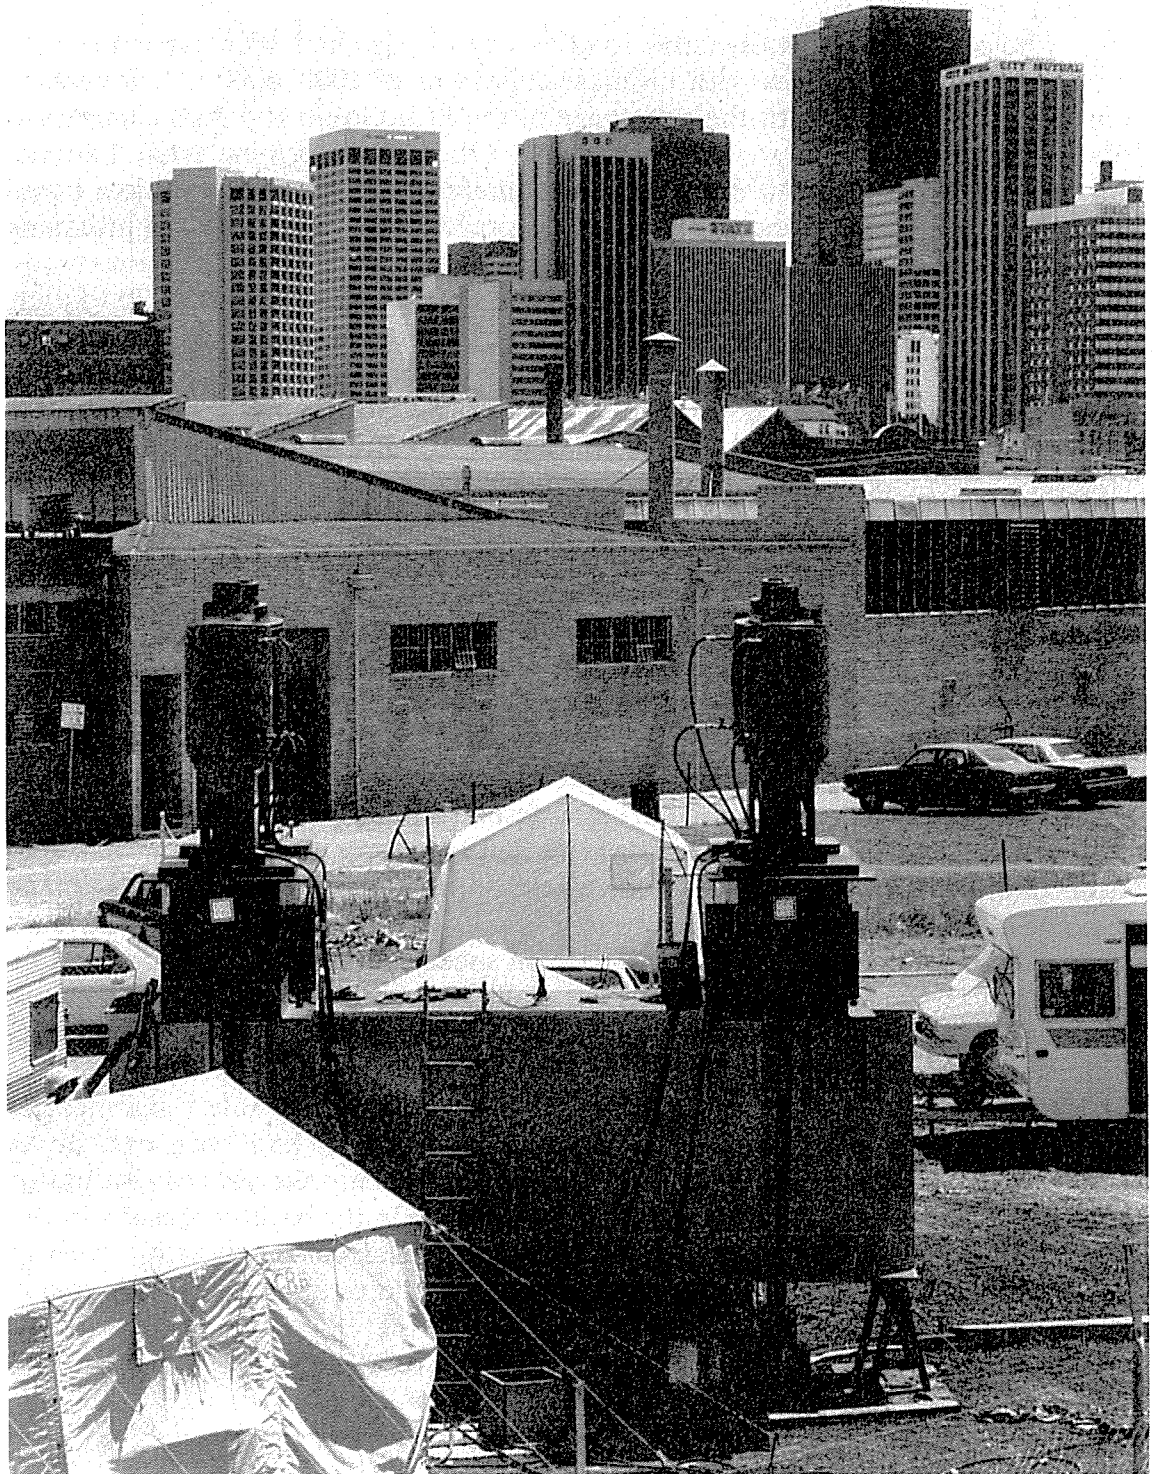
*Fig. 16. Static pile load test*
