West Gate Freeway – by David Jellie

The West Gate Freeway links the Princes Freeway in the west to the Monash Freeway in the east – a distance of 13.7 km. Its most prominent feature is the West Gate Bridge over the Yarra River.

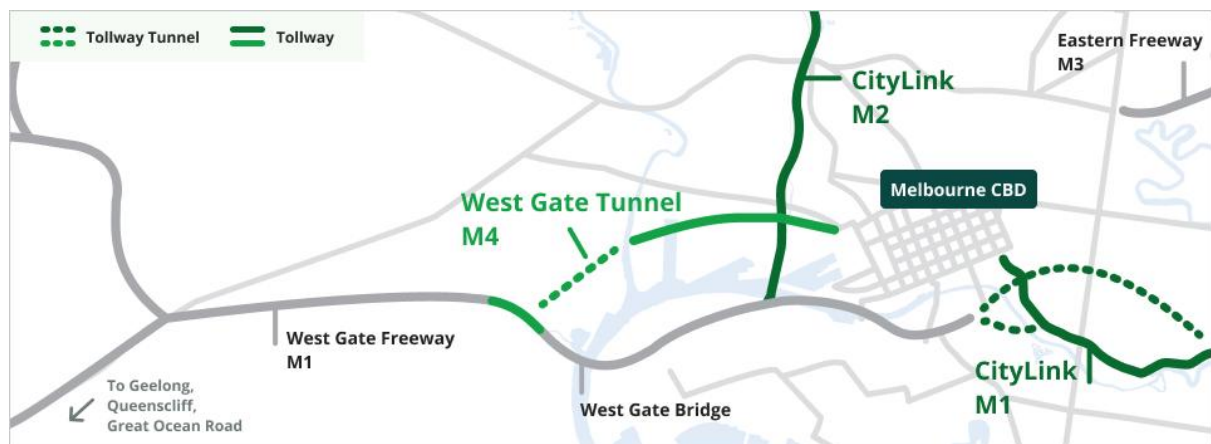
This schematic map shows the West Gate Freeway extending from the Princes Freeway in the west to the portal of the Burnley Tunnel in the east. It also shows the later connections to the West Gate Tunnel, CityLink and the Monash Freeway east of the Burnley Tunnels.

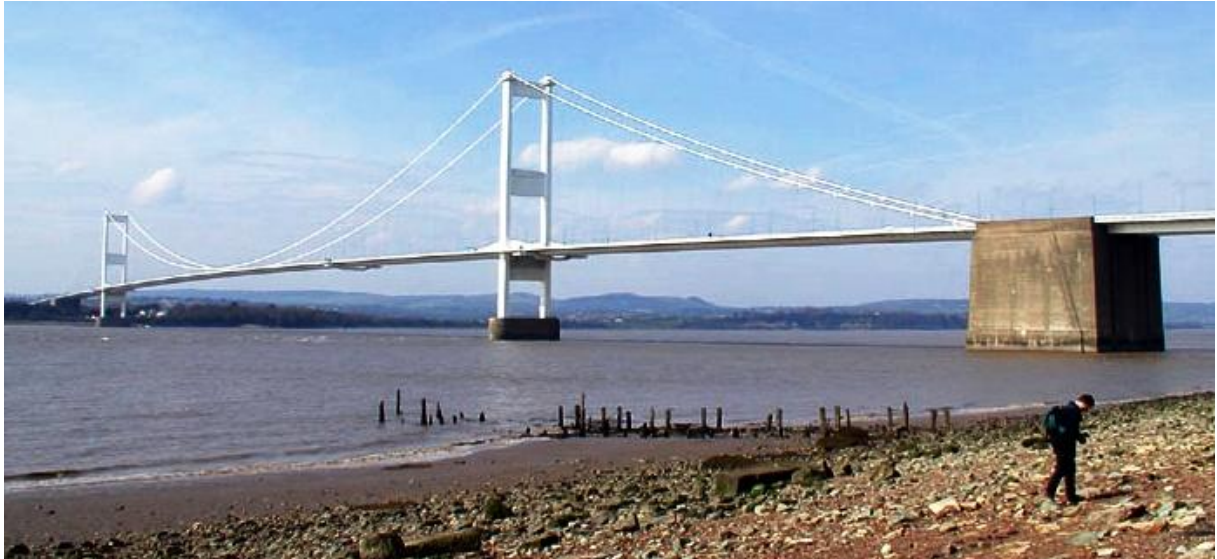
View of the Severn Bridge designed by FFP and opened in 1966.

The LYCA engaged a world-renowned British consulting firm, Freeman Fox and Partners (FFP), to design a cable-stayed bridge. FFP specialized in the design of large, steel bridges the most notable of which was the first Severn Bridge (main span 988 m) opened by Queen Elizabeth II in 1966. The Severn Bridge is a motorway suspension bridge that spans the River Severn between South Gloucestershire in England and Monmouthshire in South East Wales.

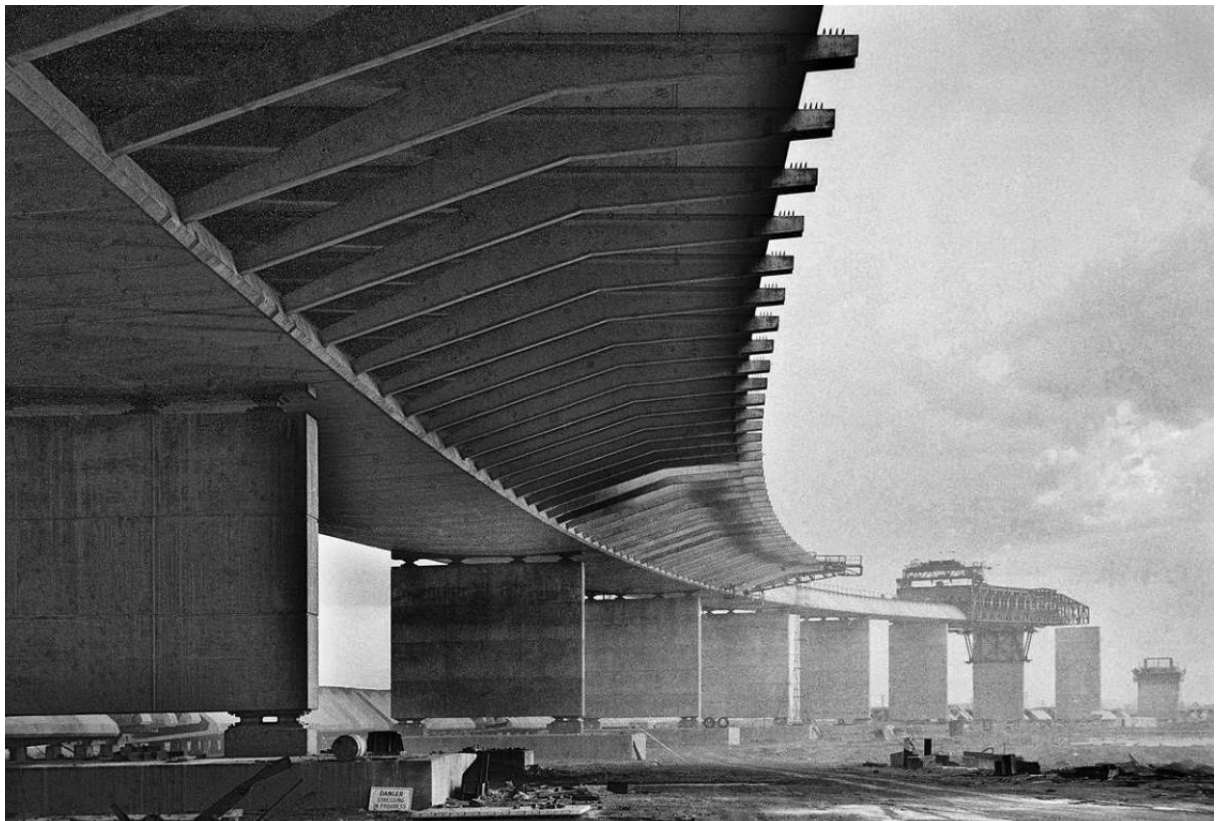
The eastern concrete approach spans being built, viewed from near Todd Road – May 1970.
(Image courtesy of Rob Morgan ARPS)

The substructure comprises concrete piers. The two towers supporting the main spans are steel and they rise 45 m above the deck to a height of 103 m above water level. The pier spacing for the river span is 336 m. The superstructure is of steel cable-stayed box girder construction for the central five spans, and pre-stressed concrete box girders elsewhere.

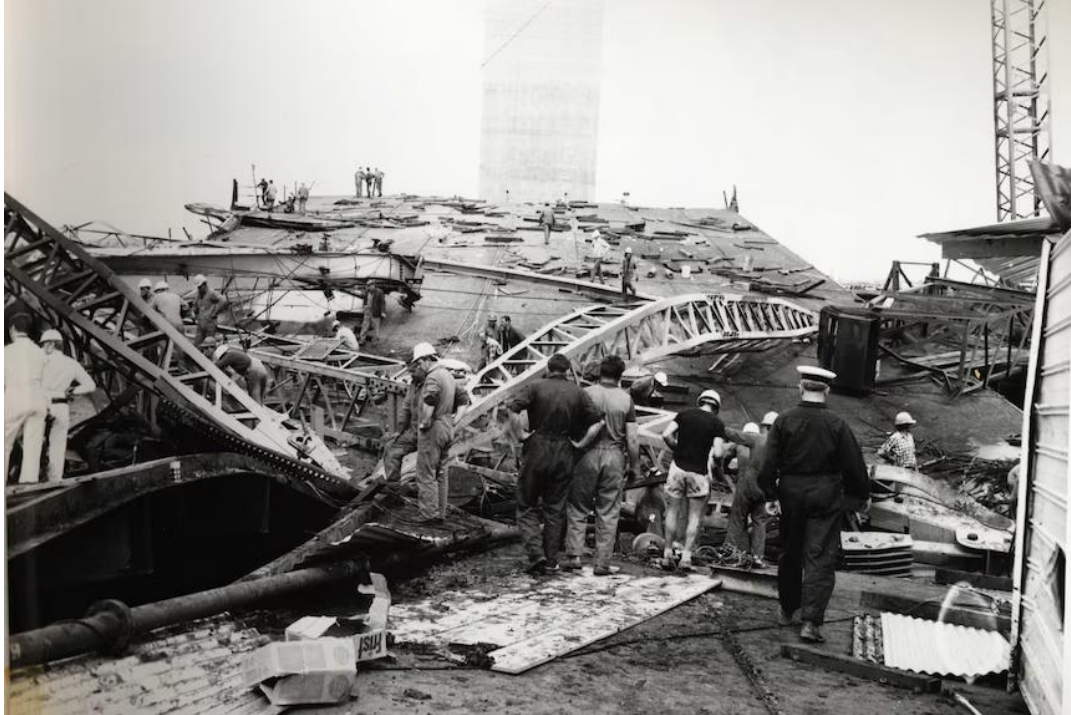
The 2,000-tonne section of the bridge that collapsed in 1970.
(Image courtesy of the Public Records Office).

- **Immediate cause:** The collapse was triggered by the removal of a large number of bolts from a transverse splice in the upper flange plating of span 10-11, an attempt to fix a buckle in the steel that had been caused by heavy loading (kentledge) to correct camber errors.

A 110 mm difference in camber was discovered where two halves of the box girder met. Instead of placing a hold on work, ten eight-tonne blocks of concrete kentledge were used on the north side of the joint in an attempt to deflect the edge to align with the edge on the south side.

This led to further buckling, and when the central bolts holding the joint together were removed, the collapse was precipitated.

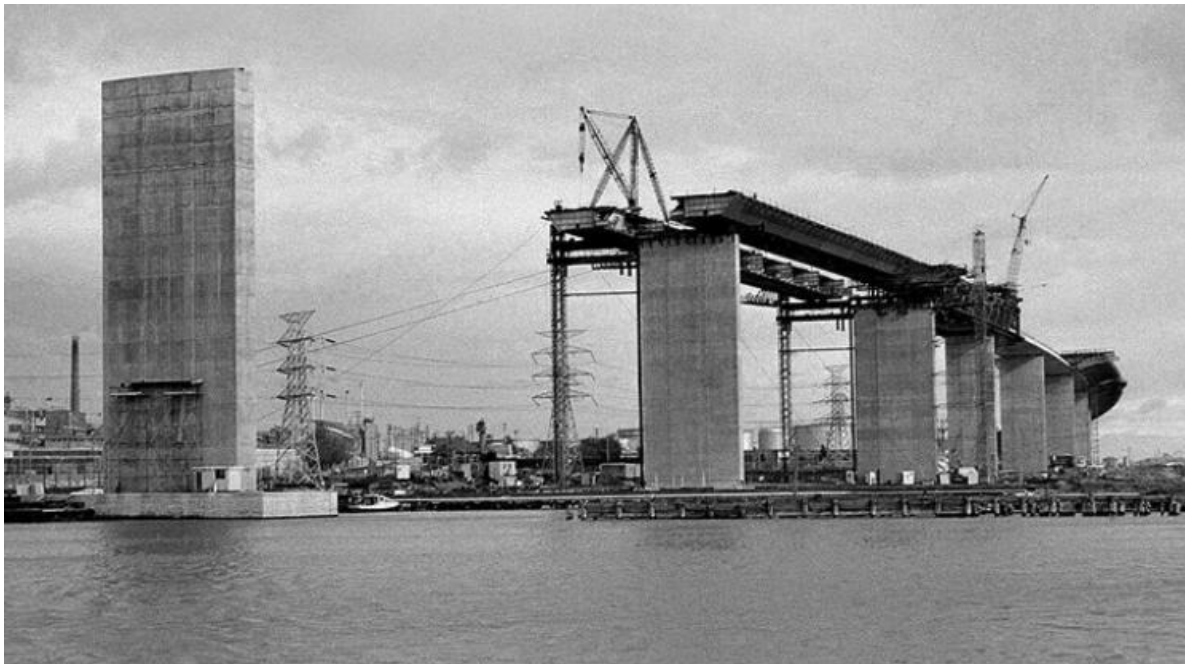
View from the eastern viewing point. Span 10-11 which collapsed in October can be seen in its two halves: the north half up on the piers and the south half jacked up to near full height, ready to be rolled across. (Image courtesy of Rob Morgan ARPS)

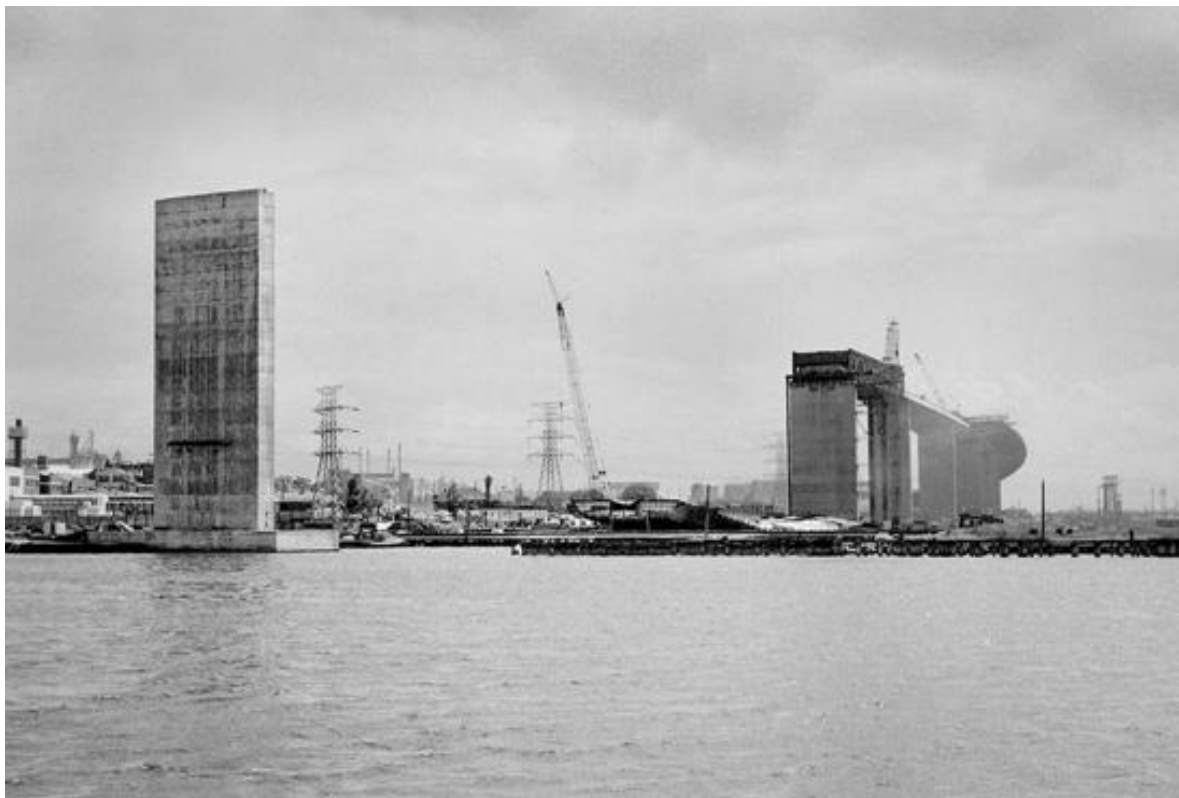
View from the eastern viewing point. Span 10-11 has collapsed, knocking over Pier 11. (Image courtesy of Rob Morgan ARPS)

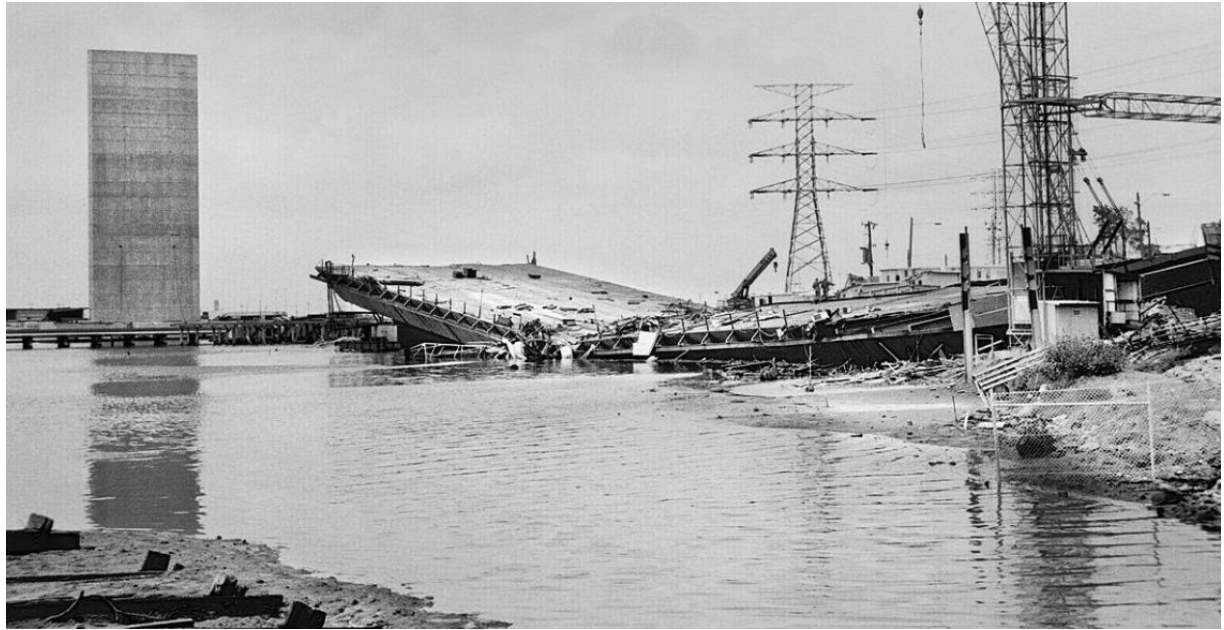
The fallen span beside Stony Creek, with Pier 12 on the left.

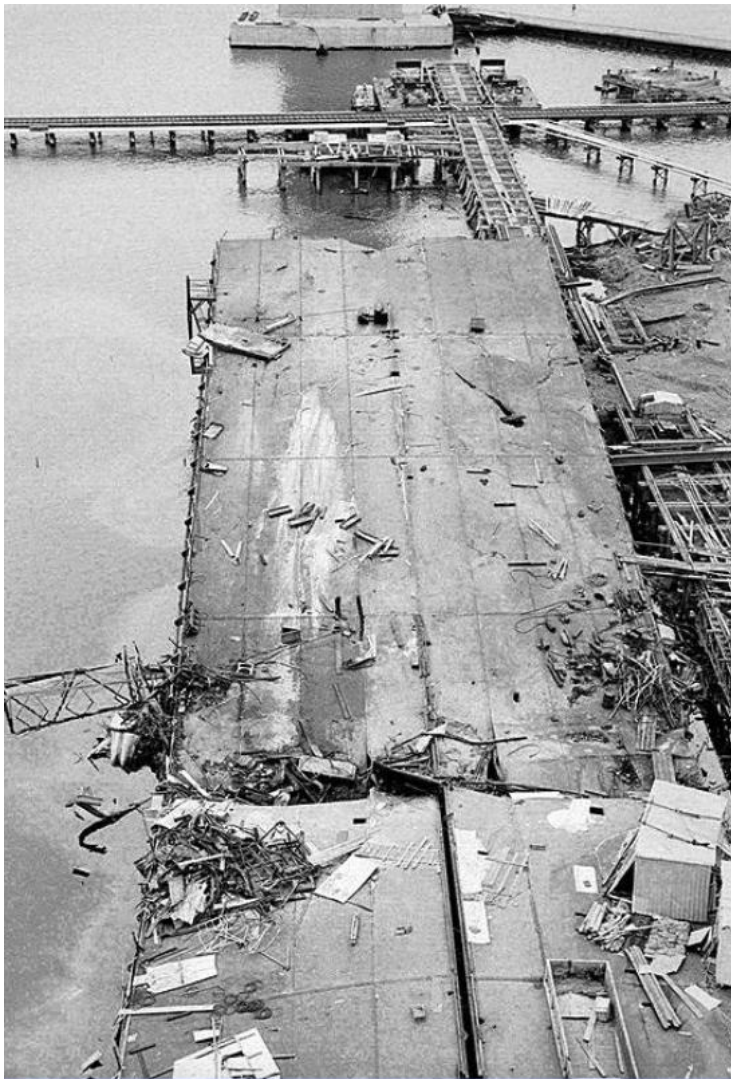
Looking down onto the fallen span from the top of Pier 10.
(Images courtesy of Rob Morgan ARPS)
